**Up-Country  
Building Inspectors, Inc.**

**GENERAL INFORMATION**

**Inspection Date:** 1-01-08.      **Inspector:** Hugh P Savage      **Report No:** XXXXXX  
**Subject Property:**      **Client's Name(s):** Daniel & Danielle Jones  
**Address:** 21 Wayout Lane      **Address:** 12 Intown Drive  
**City:** Somewhere      **City:** Downtown  
**State, Zip:** ME 00000      **State, Zip:** ME 00000

**Main entry faces:** North      **Estimated age of house:** 30 (±) yrs.  
**Building Type:** Single Family      **Soil:** Totally snow covered  
**Stories:** 2      **Weather:** Clear  
**Foundation:** Basement      **Temperature:** 40 °F  
**People Present:** Buyer Inspector Agent

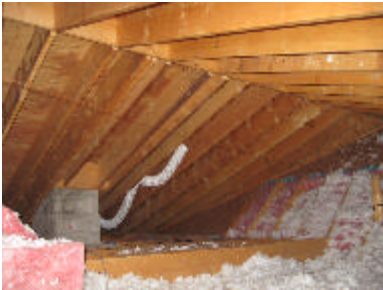
#### BTH1

Bath vent discharged into attic. This may wet insulation and/or cause mold growth in roof framing. Vent duct should discharge directly to exterior either through roof or out gable end wall. Insulate duct to prevent condensation inside duct.

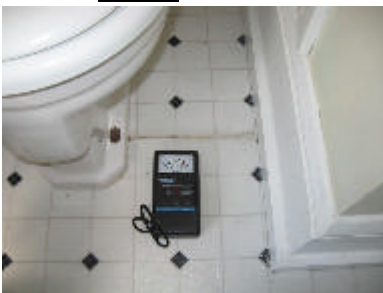
#### BTH2

Toilet leaking at base. Note: high reading on moisture meter dial in photo at left indicates dampness below the flooring. Most likely the seal has dried out. Shut off water to toilet, remove toilet from floor, remove and replace beeswax seal and replace toilet being sure the seal is compressed. Floor around toilet tested damp and may be decayed. Damage to floor may be apparent when toilet removed. Extent of damage may not be known until repair work has begun.
